DEPARTMENT OF TRANSPORTATION

Quality Assurance and Source Inspection

WELDING INSPECTION REPORT

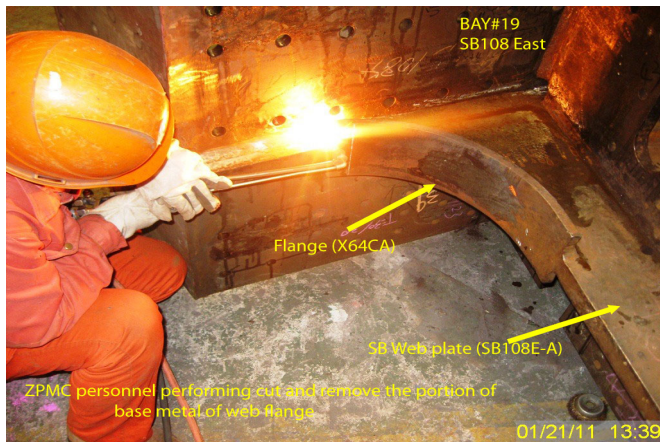
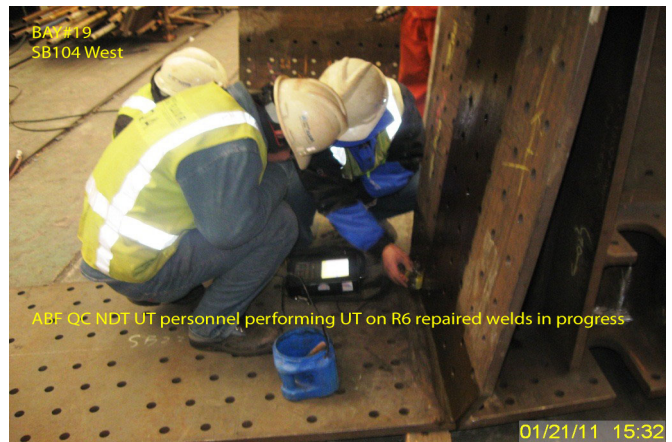
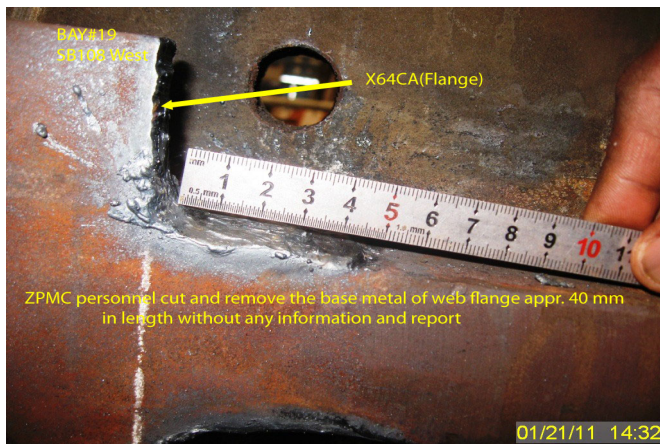
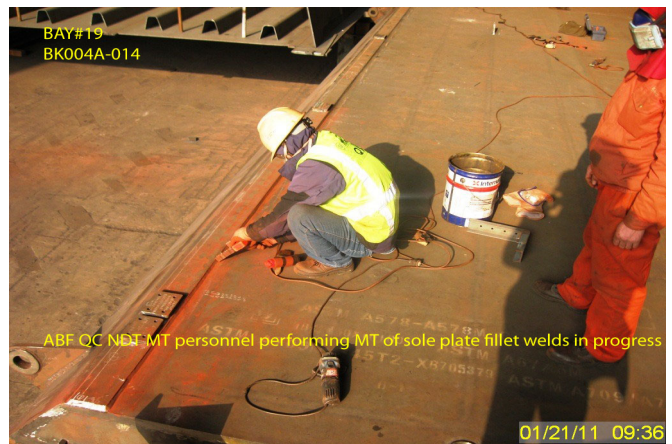
-ZPMC personnel had performed base metal cutting of X64CA flange and removed from the suspender bracket web, which do not comply with the approved shop drawings.

-This cutting was performed without prior approval of the engineer.

- The X64CA flange was welded with the web plate SB108E-A, Complete Joint Penetration (CJP) weld.
